# Complete Loss of ICD Programmability After Magnetic Resonance Imaging

**FIEK, M., ET AL.: Complete Loss of ICD Programmability After Magnetic Resonance Imaging.** *The purpose of this case report is to describe the effects of an MRI performed on a patient without realizing that an ICD has been previously implanted. After a few seconds of imaging the adversity was recognized and the examination was stopped immediately. The patient was not pacemaker dependent and had neither physical complaints nor electrocardiographic changes in the surface ECG. A consecutively performed ICD assessment showed a backup mode with standard parameters for pacing (VVI 50 beats/min) and arrhythmia detection and treatment. The device could not be programmed by the external programmer. With the exception of printing out the parameters, all software functions were no longer feasible. A device examination by the manufacturer after ICD replacement showed that a major portion of the device memory was corrupt. Even ICDs of a newer generation are susceptible to magnetic interference, with the danger of complete loss of programmability. (PACE 2004; 27:1002–1004)*

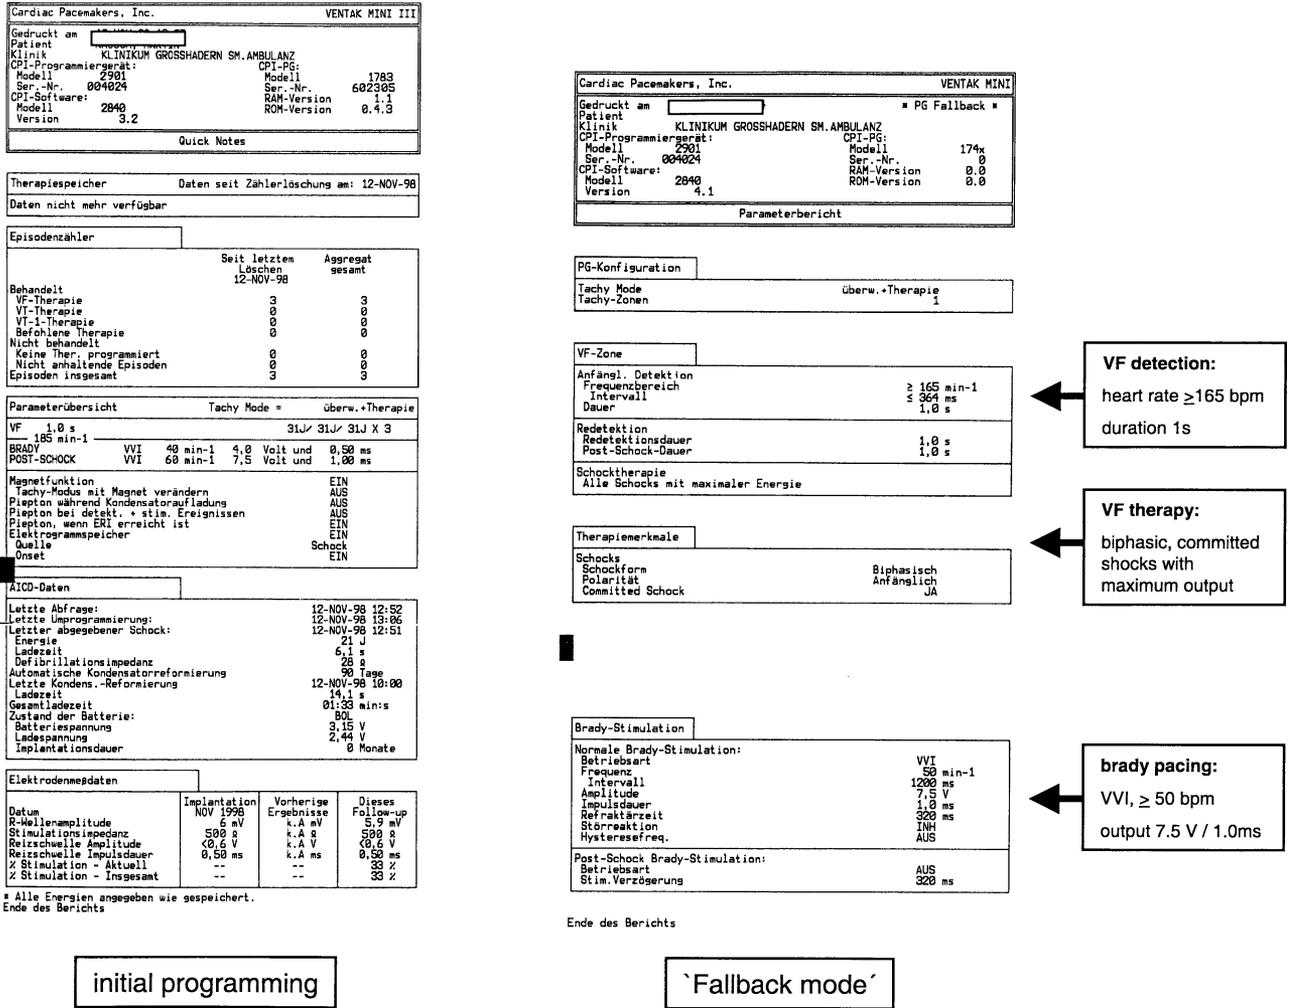
An ICD assessment was performed on the same day. After interrogation, a screenshot titled 'PG fallback' appeared. The documented software parameters showed a complete change compared to the presetting (Fig. 1). VF detection was lowered to 165 beats/min, bradypacing now showed an intervention frequency of 50 beats/min with maximum output. All attempts of reprogramming failed, with the exception of printing a simplified parameter protocol, it was no longer possible to perform programming maneuvers. The patient was monitored in an intermediate care unit, the defibrillator was replaced the following day.

The explanted device was sent to the manufacturer for further examination. A lab analysis revealed a fault code in the memory which indicated the device had been reset. It could also be demonstrated that a major portion of the device memory was corrupt.

Figure 1. Printout of the ICD software parameters pre- and post-MRI. On the right side the simplified parameter protocol after the interference.
